WATER MONITORING REPORT

MONITORING THE ECOLOGICAL CONDITIONS THAT CONSERVE THE ENDANGERED ZUNI BLUEHEAD SUCKER IN THE RIO NUTRIA PRESERVE

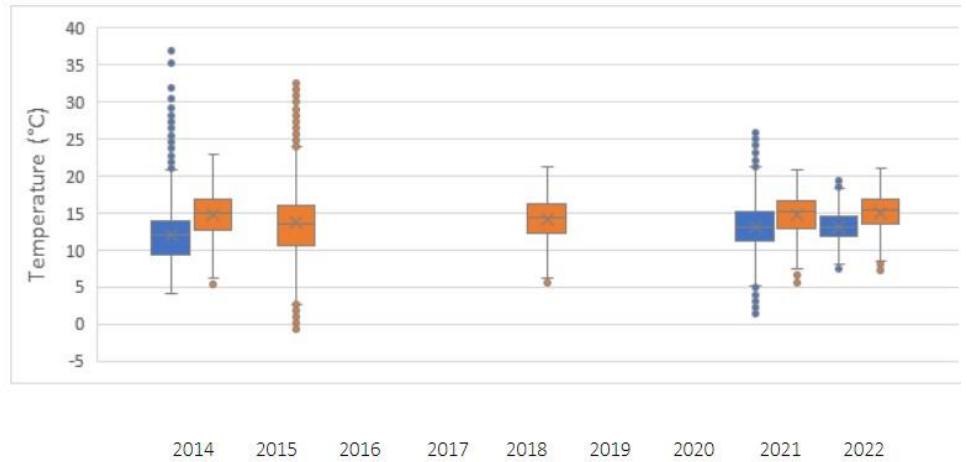
Figure 3. Water temperatures recorded at the Rio Nutria (orange) and Tampico Draw (blue) sites between May 15th and October 13th, 2014-2022

Water temperatures were measured in the deepest part of Tampico Draw and Rio Nutria pools, both of which are around 18 inches deep. Data revealed occasional critical warming (above 30° C) in the summer, especially June and July. The overall trend is of increasing water temperatures since 2014, although our sample size is small. Rising water temperatures could pose a threat to the Zuni bluehead sucker given that as water temperatures rise, dissolved oxygen and water levels decline.

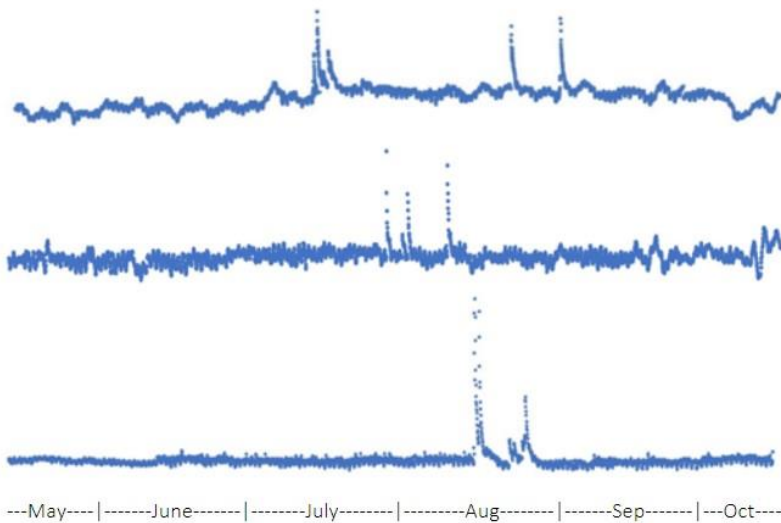
Figure 4. Water levels at the Rio Nutria site between May 15th and October 15th, 2018 (top), 2021 (middle), and 2022 (bottom)

Water level was monitored in the Rio Nutria pool from late spring to early fall in 2018, 2021, and 2022. Data showed four to five major flood pulses per monsoon season clustered between July 14th and September 1st. On average, flood events lasted 15 hours with a range of 10 to 28 hours. Major flood events have the potential to wash fish out of the system, while sustained drought could lower water beyond critical levels.
